# 18º Congresso Brasileiro de Geologia de Engenharia e Ambiental

## Capitólio Rockslide in Brazil: Causes, Effects, and Lessons Learned

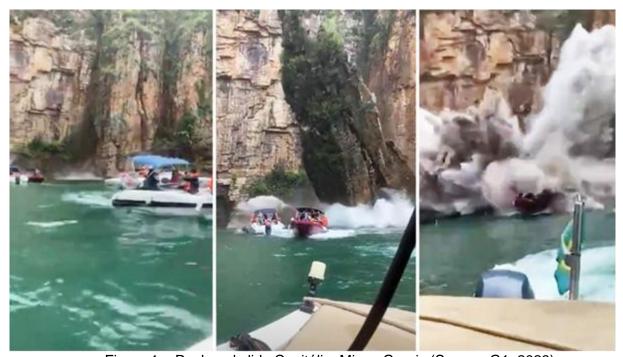
Figure 1 – Rock rockslide Capitólio, Minas Gerais (Source: G1, 2023).

The rockslide took place during a period of heavy rain that affected the region, contributing to the saturation of the rocks and exacerbating instability (G1, 2022a). The rock block that detached was approximately 25 meters long and 15 meters wide, and its fall had a direct impact on the boats, causing significant material damage to the local infrastructure and the tourism industry (CNN Brasil,

The detachment of the rock block was likely triggered by the combination of climatic and geological factors. The accumulation of water in the structure and subsequent loss of strength caused a failure at a critical point of the slope, resulting in a large-scale rock toppling (Jin, et al., 2024). The fracturing process was accelerated by the combination of rock weathering and the additional load imposed by water, leading to the fall of a large rock block approximately 25 meters in length (G1, 2022).
